**Flood Control Project Maintenance
Levee Inspections**

Fall 2016 Levee Maintenance Deficiency Summary Report

Reclamation District No. 1601 Twitchell

Levee Inspection Report By Mile - Fall 2016

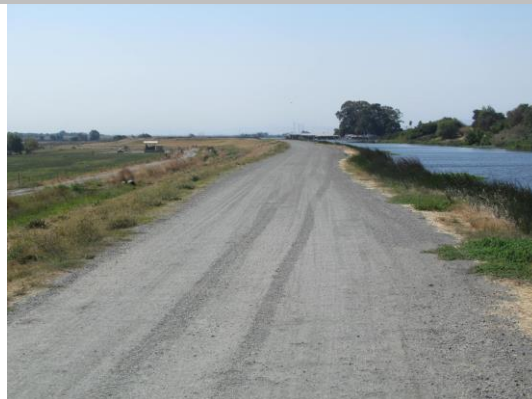
Photo 1 of 1 : FA_2016_RD1601_237_13_20160909_00019.jpg

LM Start	0.00	Rating **	A	Issue No.	13	
LM End	0.25	Issue Type +	Ma	Location *	CR	
Category	Earthen Levee			GPS Latitude/Longitude		
				Start		End
Item	Crown Surface / Depressions / Rutting			38.122235 °	°	
				-121.682553 °	°	
DWR ID	DWR_RD1601_01_s_2015_13					
Comment Code						
C2 : Repair depressions or ruts in the crown or slope.						
Inspector Comment						
Acceptable levee crown.

Looking south at overview of levee. Fall 2016.

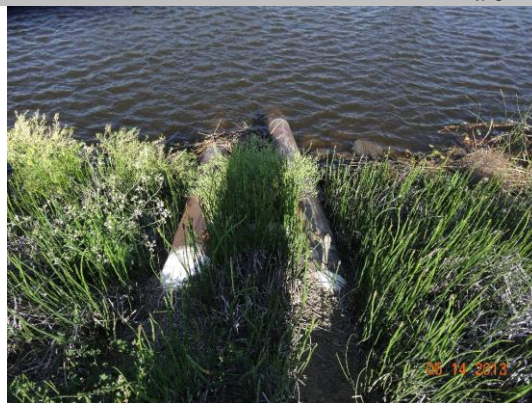
Photo 1 of 2 : UCIP_FA_2016_22043_37621.jpg

Comment Code					
Inspector Comment					
FS_ID:22043 DS_ID:20950 EP_NO: 11227 Repair Type: Non-Urgent Crossing Status: Found UCIP Comments: Appears this crossing might be been recently modified--exposed section of pipe is protected with white paint. Need to contact owner to obtain records. Recommend clearing vegetation along the pipe alignment. FIELD_STRUCT_DESC: 14-inch pipe (not 12-inch pipe as original description noted) through the levee, 4.0 feet below the crown. Siphon primer on waterward shoulder. 36-inch steel (not concrete as original description noted) pipe with shut-off valve inside at landward toe ditch. (ABO No. 11227-1975) FS Date: 5/14/2013

View of waterward side. 12-inch pipe to the right and 14-inch pipe to the left.

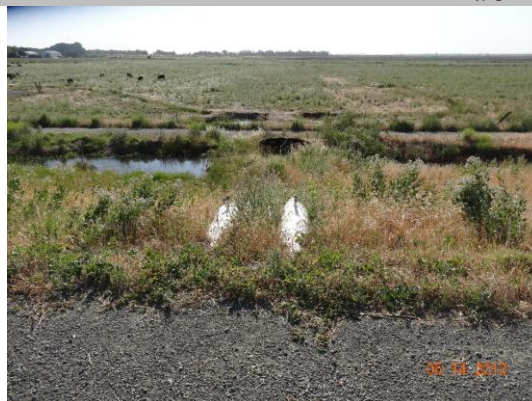
Photo 2 of 2 : UCIP_FA_2016_22043_37622.jpg

Comment Code						
Inspector Comment						
FS_ID:22043 DS_ID:20950 EP_NO: 11227 Repair Type: Non-Urgent Crossing Status: Found UCIP Comments: Appears this crossing might be been recently modified--exposed section of pipe is protected with white paint. Need to contact owner to obtain records. Recommend clearing vegetation along the pipe alignment. FIELD_STRUCT_DESC: 14-inch pipe (not 12-inch pipe as original description noted) through the levee, 4.0 feet below the crown. Siphon primer on waterward shoulder. 36-inch steel (not concrete as original description noted) pipe with shut-off valve inside at landward toe ditch. (ABO No. 11227-1975) FS Date: 5/14/2013

View of landward side with canal located at toe.

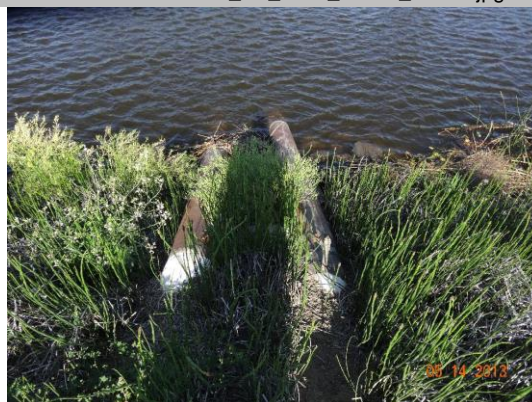
Photo 1 of 2 : UCIP_FA_2016_42024_60809.jpg

Comment Code						
Inspector Comment						
FS_ID:42024 DS_ID:20953 EP_NO: N/A Repair Type: Non-Urgent Crossing Status: Found UCIP Comments: Appears this crossing might have been recently modified--O&M manual calls for 8 inch pipe not 12 inch pipe, need additional information--exposed section of pipe is protected with white paint. Need to contact owner to obtain records. Recommend clearing vegetation along the pipe alignment. FIELD_STRUCT_DESC: 12-inch (not 8 inch listed in USACE) siphon through the levee approximately 3.2 feet below the crown. The existing 8-inch pipe listed in the O&M manual is no longer present at LM 0.1 (USACE-1959), no permit was found authorizing crossing modifications. FS Date: 5/14/2013

View of waterward side. 12-inch pipe on the right (u/s) and 14-inch pipe on the left (d/s).

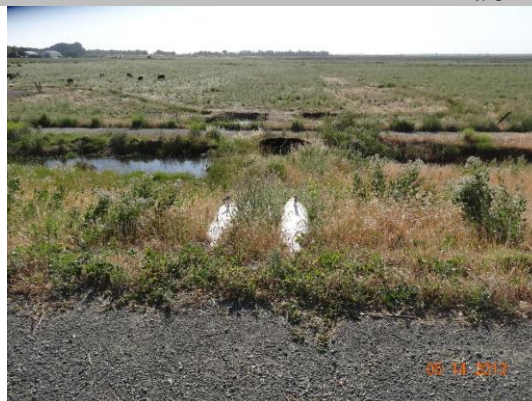
Photo 2 of 2 : UCIP_FA_2016_42024_60810.jpg

Comment Code						
Inspector Comment						
FS_ID:42024						
DS_ID:20953						
EP_NO: N/A						
Repair Type: Non-Urgent						
Crossing Status: Found						
UCIP Comments: Appears this crossing might have been recently modified--O&M manual calls for 8 inch pipe not 12 inch pipe, need additional information--exposed section of pipe is protected with white paint. Need to contact owner to obtain records. Recommend clearing vegetation along the pipe alignment.						
FIELD_STRUCT_DESC: 12-inch (not 8 inch listed in USACE) siphon through the levee approximately 3.2 feet below the crown. The existing 8-inch pipe listed in the O&M manual is no longer present at LM 0.1 (USACE-1959), no permit was found authorizing crossing modifications.						
FS Date: 5/14/2013

View of pipes from landward shoulder. Levee is a gravel road.

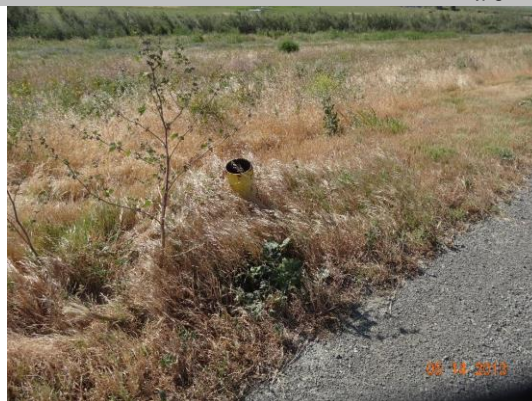
Photo 1 of 2 : UCIP_FA_2016_39946_71862.jpg

LM Start	0.79	Rating **	M	Issue No.	17
LM End	0.79	Issue Type +	En	Location *	CR
Category	Supplemental			GPS Latitude/Longitude	
				Start	End
Item	DWR UCIP Field Study			38.111078 °	38.111078 °
				-121.682011 °	-121.682011 °
DWR ID					
Comment Code					
Inspector Comment					
FS_ID:39946 DS_ID:24069 EP_NO: N/A Repair Type: Non-Urgent Crossing Status: Indicator Found UCIP Comments: Unable to determine if line crosses levee. Need to contact owner to determine if crossing goes through levee. Also need to determine permit authorizing work on landward side. FIELD_STRUCT_DESC: Steel stand pipe with PVC pipe inside located on landward shoulder. Rip rap located on waterward slope. Unable to determine if crossing goes through levee. Appears to be monitoring gas well. FS Date: 3/19/2009

View of landward side--standpipe located on slope.

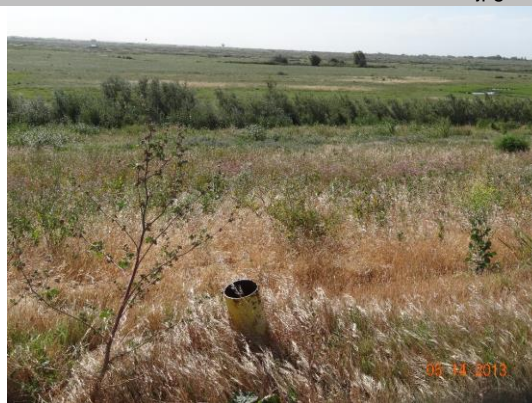
Photo 2 of 2 : UCIP_FA_2016_39946_71860.jpg

View of landward side--dense vegetation along slope.

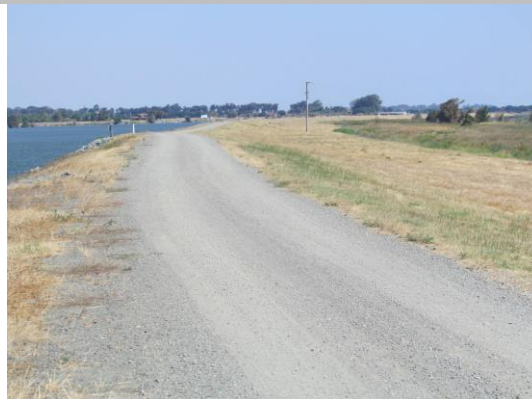
Photo 1 of 1 : FA_2016_RD1601_237_2_20160909_00020.jpg

LM Start	1.00	Rating **	A	Issue No.	2
LM End	1.07	Issue Type +	Ma	Location *	CR
Category	Earthen Levee			GPS Latitude/Longitude	
				Start	End
Item	Crown Surface / Depressions / Rutting			38.108088 °	38.107128 °
				-121.682784 °	-121.683190 °
DWR ID	DWR_RD1601_01_f_2015_2				
Comment Code					
C2 : Repair depressions or ruts in the crown or slope.					
Inspector Comment

Looking northwest at overview of levee.

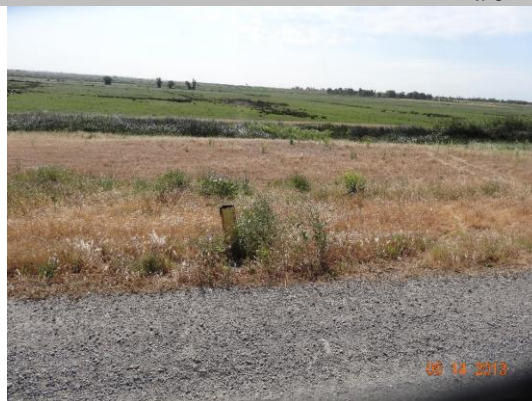
Photo 1 of 2 : UCIP_FA_2016_39947_71865.jpg

LM Start	1.40	Rating **	M	Issue No.	18
LM End	1.40	Issue Type +	En	Location *	CR
Category	Supplemental			GPS Latitude/Longitude	
				Start	End
Item	DWR UCIP Field Study			38.102422 °	38.102422 °
				-121.684289 °	-121.684289 °
DWR ID					
Comment Code					
Inspector Comment					
FS_ID:39947 DS_ID:24068 EP_NO: N/A Repair Type: Non-Urgent Crossing Status: Indicator Found UCIP Comments: Unable to determine if line crosses levee. Need to contact owner to determine if crossing goes through levee. Also need to determine permit authorizing work on landward side. FIELD_STRUCT_DESC: Steel stand pipe with PVC pipe inside located on landward shoulder. Rip rap located on waterward slope. Unable to determine if crossing goes through levee. Appears to be monitoring gas well. FS Date: 3/19/2009

View of landward side.

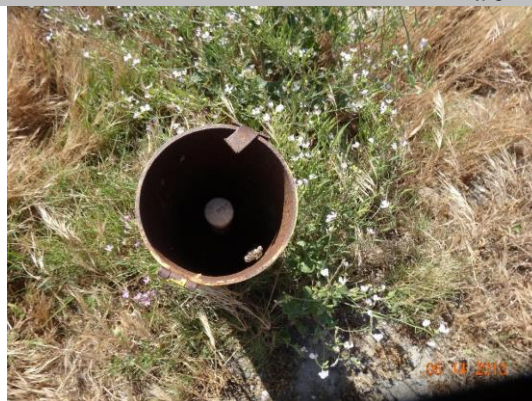
Photo 2 of 2 : UCIP_FA_2016_39947_71866.jpg

LM Start	1.40	Rating **	M	Issue No.	18 (cont)	
LM End	1.40	Issue Type +	En	Location *	CR	
Category	Supplemental			GPS Latitude/Longitude		
				Start		End
Item	DWR UCIP Field Study			38.102422 °	38.102422 °	
				-121.684289 °	-121.684289 °	
DWR ID						
Comment Code						
Inspector Comment						
FS_ID:39947 DS_ID:24068 EP_NO: N/A Repair Type: Non-Urgent Crossing Status: Indicator Found UCIP Comments: Unable to determine if line crosses levee. Need to contact owner to determine if crossing goes through levee. Also need to determine permit authorizing work on landward side. FIELD_STRUCT_DESC: Steel stand pipe with PVC pipe inside located on landward shoulder. Rip rap located on waterward slope. Unable to determine if crossing goes through levee. Appears to be monitoring gas well. FS Date: 3/19/2009

PVC inside standpipe located on landward side.

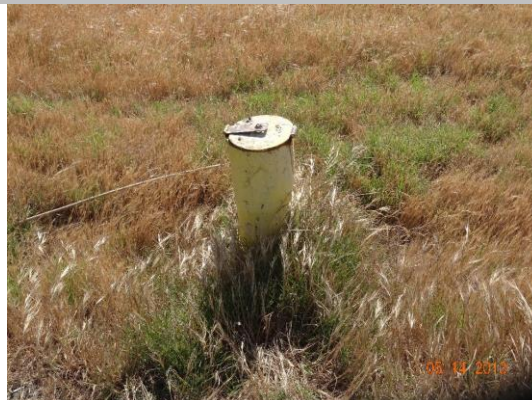
Photo 1 of 2 : UCIP_FA_2016_39948_71869.jpg

LM Start	1.77	Rating **	M	Issue No.	19	
LM End	1.77	Issue Type +	En	Location *	CR	
Category	Supplemental			GPS Latitude/Longitude		
				Start		End
Item	DWR UCIP Field Study			38.097105 °	38.097105 °	
				-121.684815 °	-121.684815 °	
DWR ID						
Comment Code						
Inspector Comment						
FS_ID:39948 DS_ID:24071 EP_NO: N/A Repair Type: Non-Urgent Crossing Status: Indicator Found UCIP Comments: Unable to determine if line crosses levee. Need to contact owner to determine if crossing goes through levee. Also need to determine permit authorizing work on landward side. FIELD_STRUCT_DESC: Steel stand pipe with PVC pipe inside located on landward shoulder. Rip rap located on waterward slope. Unable to determine if crossing goes through levee. Appears to be monitoring gas well. FS Date: 3/19/2009

Standpipe located on landward side.

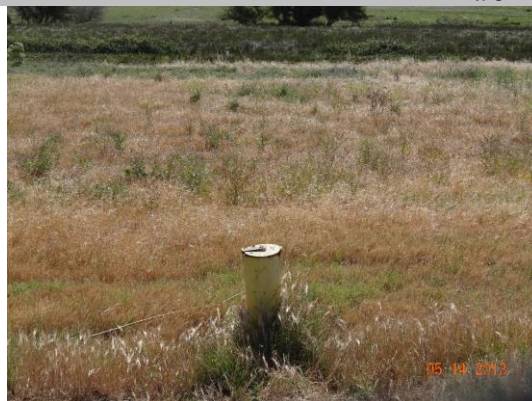
Photo 2 of 2 : UCIP_FA_2016_39948_71868.jpg

LM Start	1.77	Rating **	M	Issue No.	19 (cont)	
LM End	1.77	Issue Type +	En	Location *	CR	
Category	Supplemental			GPS Latitude/Longitude		
				Start		End
Item	DWR UCIP Field Study			38.097105 °		38.097105 °
				-121.684815 °		-121.684815 °
DWR ID						
Comment Code						
Inspector Comment						
FS_ID:39948 DS_ID:24071 EP_NO: N/A Repair Type: Non-Urgent Crossing Status: Indicator Found UCIP Comments: Unable to determine if line crosses levee. Need to contact owner to determine if crossing goes through levee. Also need to determine permit authorizing work on landward side. FIELD_STRUCT_DESC: Steel stand pipe with PVC pipe inside located on landward shoulder. Rip rap located on waterward slope. Unable to determine if crossing goes through levee. Appears to be monitoring gas well. FS Date: 3/19/2009

View of landward side.

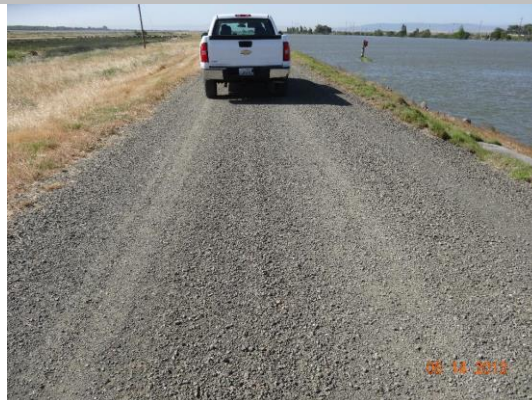
Photo 1 of 2 : UCIP_FA_2016_19545_33173.jpg

Comment Code					
Inspector Comment					
FS_ID:19545					
DS_ID:20951					
EP_NO: 2909A					
Repair Type: Non-Urgent					
Crossing Status: Found					
UCIP Comments: Appears this crossing might be been recently modified--exposed section of pipe is protected with white paint. Need to contact owner to obtain records. Recommend clearing vegetation along the pipe alignment. Dense vegetation on landward slope limits the inspector's visibility to identify signs of leaks along levee slope.					
FIELD_STRUCT_DESC: 8-inch siphon pipe through levee, 2.4 feet below crown. Cutoff wall around pipe at center of levee. Siphon breaker on apex of pipe on landward shoulder. Hand primer pump on landward slope. (Permit No. 2909A-1960)					
FS Date: 5/14/2013

View of levee crown looking downstream at crossing.

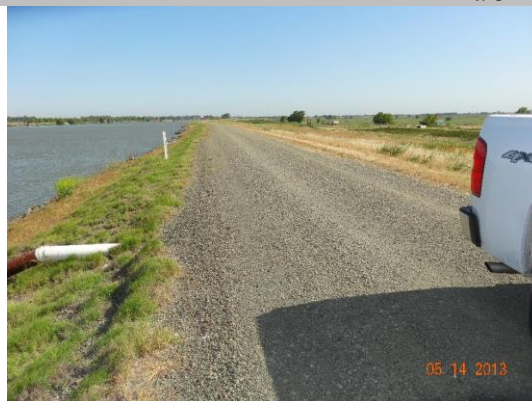
Photo 2 of 2 : UCIP_FA_2016_19545_33174.jpg

Comment Code						
Inspector Comment						
FS_ID:19545 DS_ID:20951 EP_NO: 2909A Repair Type: Non-Urgent Crossing Status: Found UCIP Comments: Appears this crossing might be been recently modified--exposed section of pipe is protected with white paint. Need to contact owner to obtain records. Recommend clearing vegetation along the pipe alignment. Dense vegetation on landward slope limits the inspector's visibility to identify signs of leaks along levee slope. FIELD_STRUCT_DESC: 8-inch siphon pipe through levee, 2.4 feet below crown. Cutoff wall around pipe at center of levee. Siphon breaker on apex of pipe on landward shoulder. Hand primer pump on landward slope. (Permit No. 2909A-1960) FS Date: 5/14/2013

View of levee crown looking upstream at crossing.
